# Manhole Inspection Summary

Manhole # S37QQ\_037MH

Insp Date: **1/16/07 10:23 AM**

**Location** Address: **449 25TH ST**

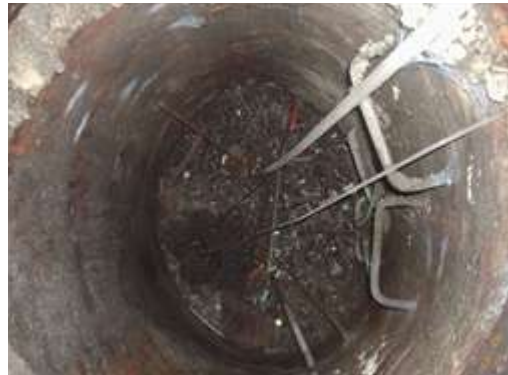
Top View

Channel debris.

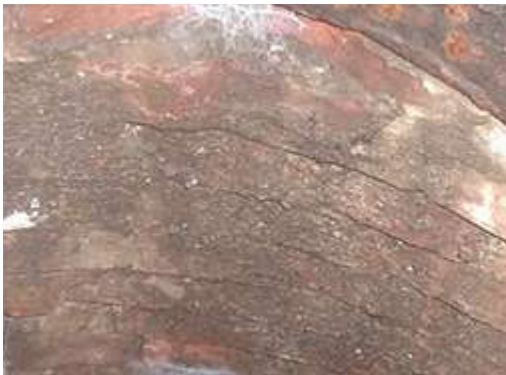
Defect

Adjustment deterioration and infiltration.  
Corbel and Barrel infiltration.

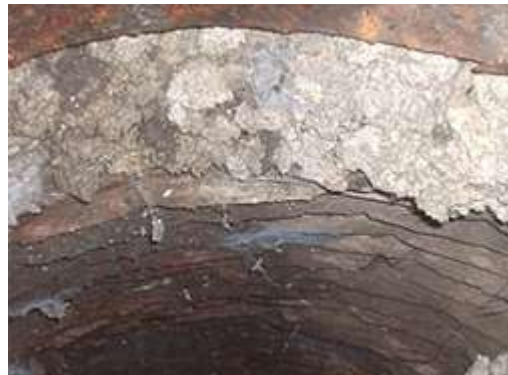
Defect

Adjustment deterioration and infiltration.  
Corbel and Barrel infiltration.

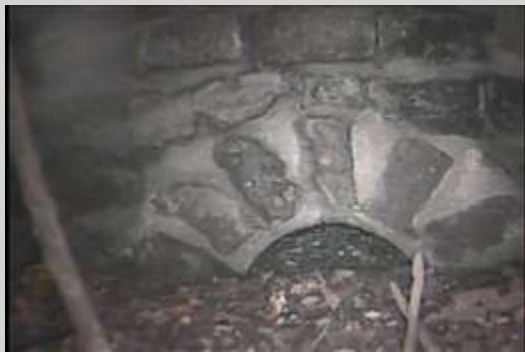
8 in. Circular Gravity Sewer  
Pipe Out @ 12 O'Clock

Deposits: ☐ None ☒ **Mud** ☐ Sludge ☒ **Debris** ☐ Grease

Silt Depth: **6** (in.) Deposits Extent: **Heavy**
